# County Project Manages Full Bridge Replacement In Less than a Month From Demo to Completion

## CTH-N Bridge

Wisconsin, USA

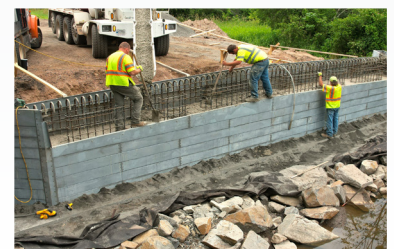
Ready-mix concrete placed in abutment.

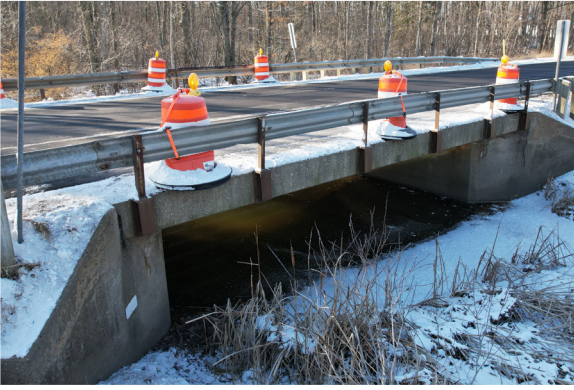
- ◇ The previous structure was built in 1945 and issues were identified in the biennial inspection, that required urgent attention.

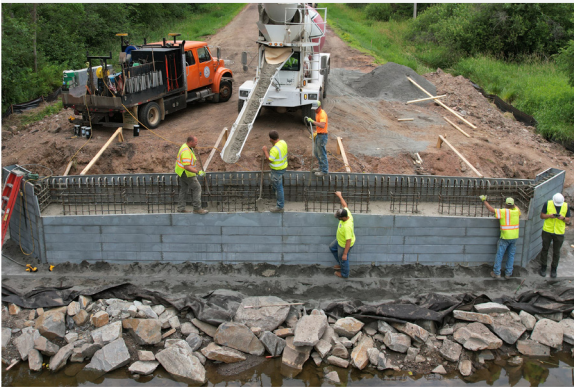
**Week 1:**

- ◇ Existing structure was demolished, and roadway excavated to increase clear-span, avoiding any disturbance to rip rap and waterway
- ◇ Steel H-piles were driven for new foundation
- ◇ InQuik abutments lifted onto foundation and filled with ready-mix concrete

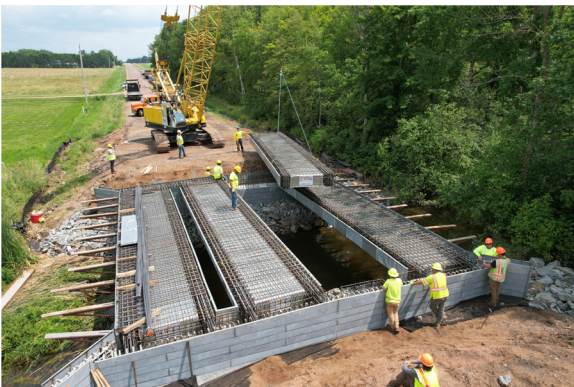
**Week 2:**

- ◇ InQuik superstructure deck panels lifted onto abutments and spliced together
- ◇ Rebar tied into structure for concrete barrier
- ◇ Concrete placed in superstructure & roadway barrier

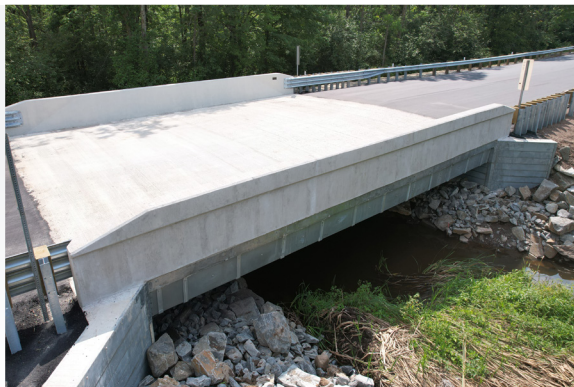
**Week 3:**

- ◇ Roadway backfilled and asphalt laid
- ◇ Rail connected to concrete barrier & signage installed
- ◇ New structure: AASHTO compliant cast-in-place integral bridge with 75+ year design-life
