County Rapidly Replaces Bridge After a Devastating Flood, And Saves Millions

144th Ave. Bridge

Colorado, USA

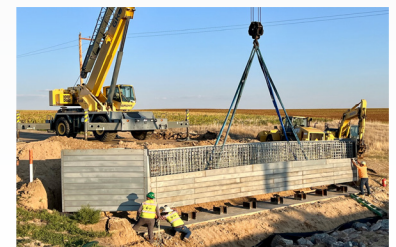
Abutment Installation

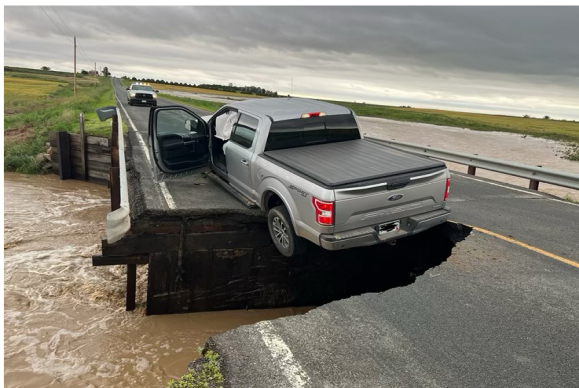
- ◇ A devastating flood destroyed a crucial bridge, calling for rapid and disaster resilient replacement

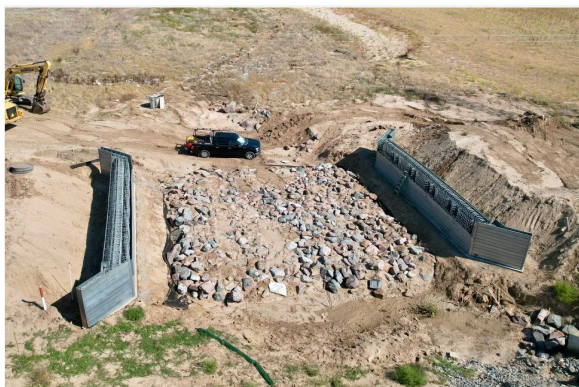
- ◇ After the consulting engineer completed the Geotech and Hydraulic investigations, it was decided to drive the steel piles for the foundation and expand the clear-span of the structure
- ◇ Prefabricated InQuik abutments and wingwalls can be lifted onto the foundation and filled with ready-mix concrete on the same day
- ◇ The new structure was designed with a larger clear-span and InQuik's innovative integral bridge to ensure future floods were not a concern

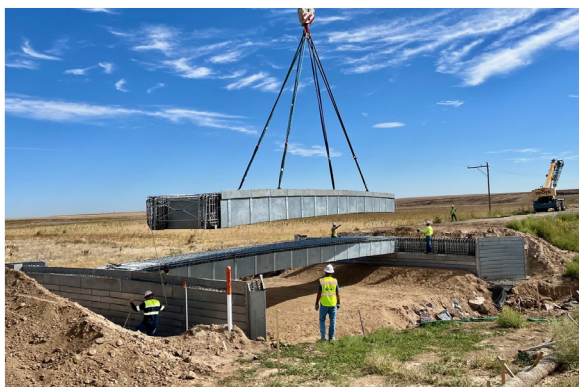
- ◇ InQuik superstructure deck panels incorporate reinforcing steel and formwork only, without concrete, so they're lightweight for easy installation
- ◇ This modular bridge required only 7 picks for installation: 2 abutments and 5 superstructure deck panels
- ◇ The contractor completed the project with only 300 man-hours as opposed to 3000 man-hours for a similar project using traditional construction processes

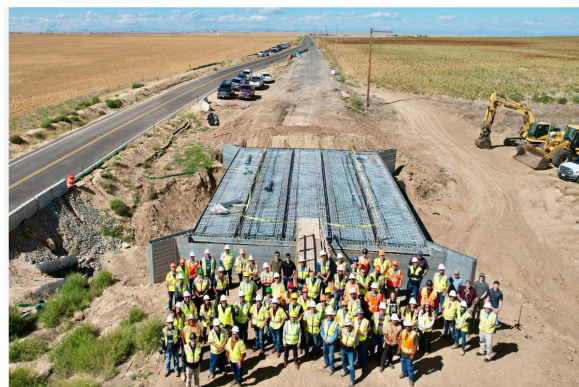
- ◇ The image highlights the interest in this project, as engineers and counties from across Colorado, came for the open day during construction
- ◇ While a temporary bypass road was constructed next to the bridge project, the total project cost was only \$2 million, as opposed to the original estimate of \$5 million
